INFORMATION ABOUT BIOSWALES AND BIORETENTION IN THE RIGHT-OF-WAY

KD 11-6-14 revised 5-27-15

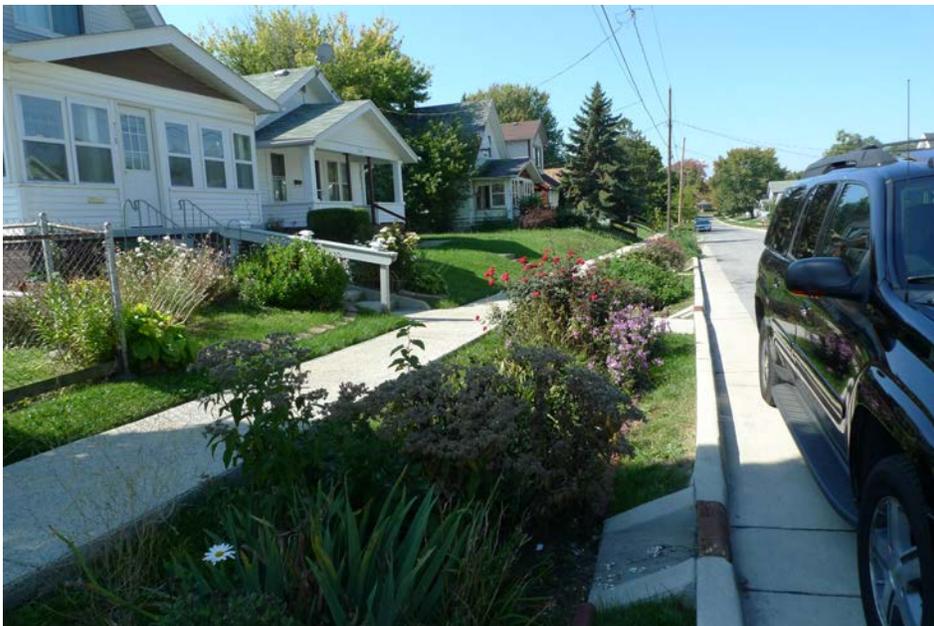
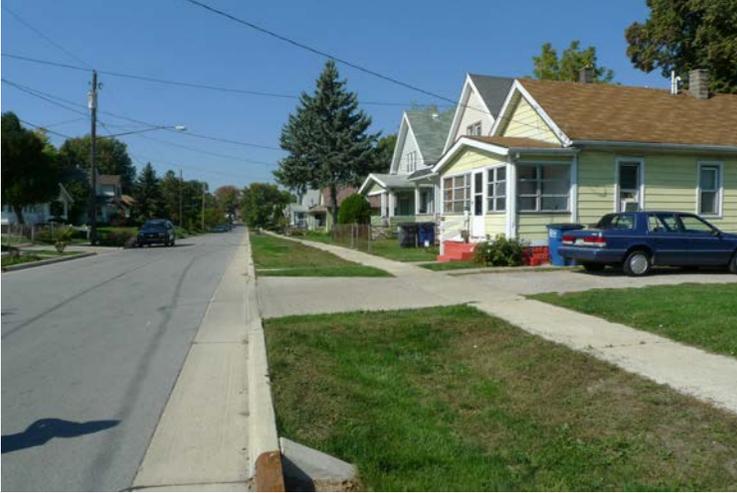
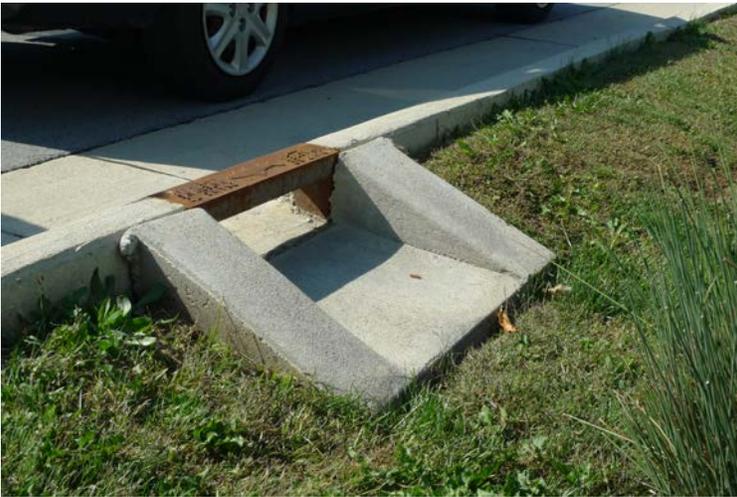
Overall. This was a pilot project installed in 2009 with American Recovery and Reinvestment Act (ARRA) funding. Maywood is a residential street with asphalt pavement and concrete curb, gutter, sidewalk and driveway aprons. As part of street reconstruction, the bioswale was installed in the 8-foot-wide planting strip (AKA tree lawn, parkway) between the curb and sidewalk on both sides of the street. Resident engagement was done door-to-door, and residents were given a choice of treatment: native plants, lawn, or trees/planting bed.

Maintenance. Maintenance is provided by the property owner, and should include weeding, mowing (if applicable) trash removal, and ensuring that inlets remain clear. Maintenance along the street appears to be good. Some property owners have chosen to replace the native plants with more traditional horticultural plants; others appear to be mowing installed lawn or possibly having let their mulch beds return to lawn. It is not clear whether the installed buffalo grass is still in place, or whether more traditional turfgrass or other weed plants have taken over.

Sediment pretreatment was not part of the Maywood project. It is not clear whether grass and soil will obstruct the inlets at some point. The system has been in place now for 5 years and it's functioning very well. It is possible that it could be 20 years until work is needed.

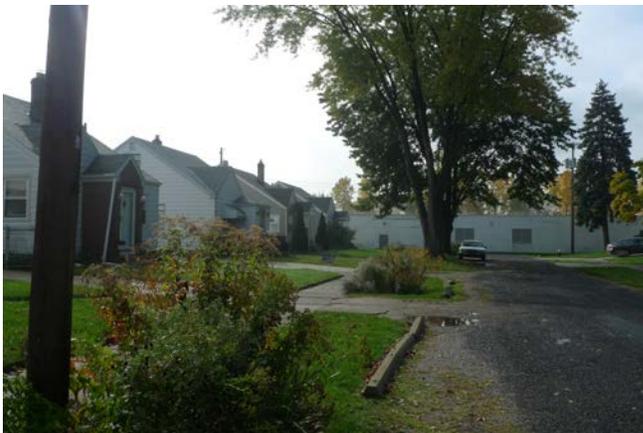
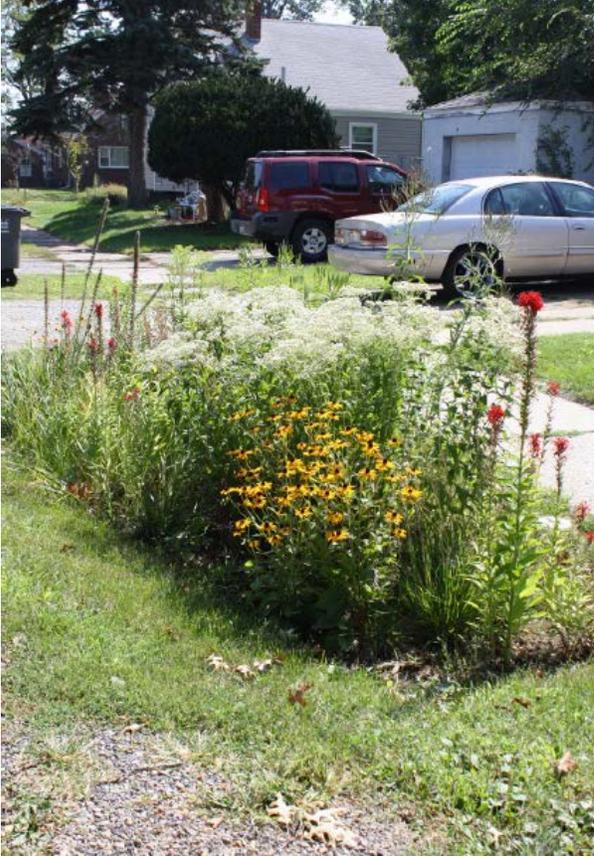
Overall. Conrad Avenue is an unimproved residential street, without curb and gutter. The purpose of the project was to clear up nuisance ponding. This was a pilot project done in 2011 (verify) with funding from the Ohio EPA Stormwater Innovation Fund (SWIF). Bioswales were provided in the planting strip between the road pavement and the sidewalk. Similar to Maywood, door-to-door resident engagement was done. Residents were given a choice of lawn, native plants, or gravel parking areas (without bioswale, draining into adjacent planter areas) to replace existing parking areas. The project did not have hydraulic design or monitoring; it was just an attempt to do what was possible in the space provided, and see if it could help with the street ponding problem. This was successfully accomplished.

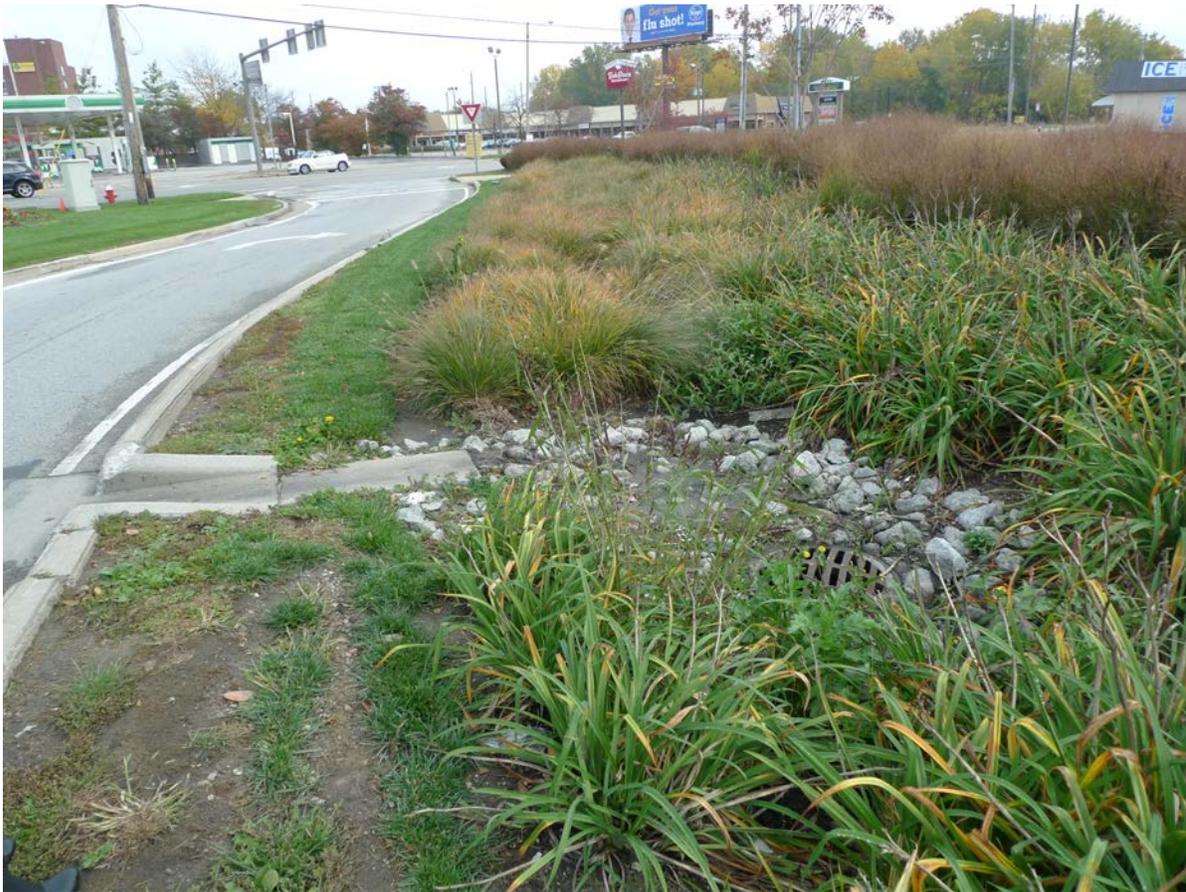
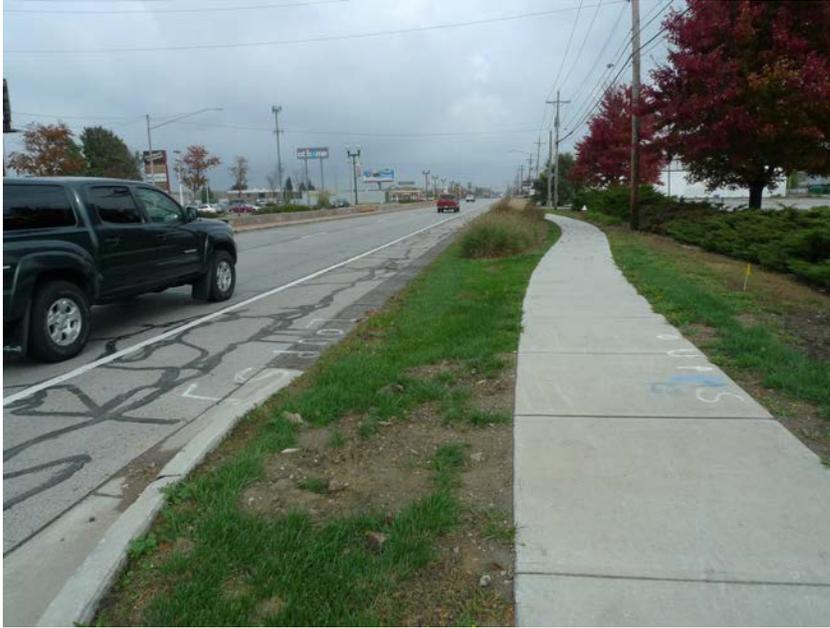
Overview. Reynolds Road is a commercial arterial, originally six lanes wide plus a central median/turning lane. As part of road reconstruction including reduction of road width one lane on each side, bioswales were introduced on both sides of the street. The project was completed in 2010-2014. Funding was provided by transportation enhancement grants, plus direct earmarks on federal transportation funding.

Maintenance. After the initial 2-year contractor establishment period, maintenance is the responsibility of the property owner and involves trash pickup and weeding. Property owners were educated about proper maintenance of plant material, and were reminded that they would be mowing lawn in these areas anyway. They were encouraged to start weeding early each season in order to reduce the effort later. It is recognized by the City that property owner education is an ongoing project to improve communication and encourage better maintenance and “ownership” of the landscape by property owners. Review of the areas showed that maintenance was generally fair to good. There has been no known maintenance on catch basins or pervious pavement gutter strips.

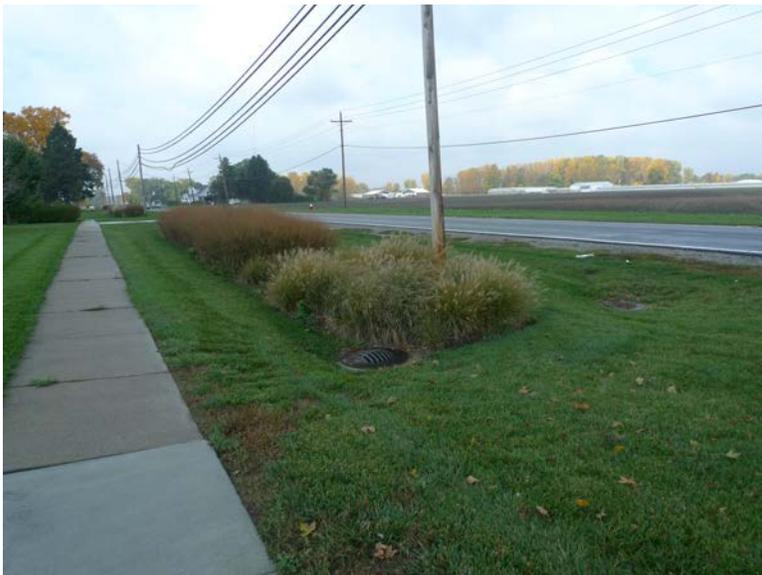
Overview. This portion of Angola Road is an arterial that runs through residential and commercial/office areas. The road is two lanes with additional turning lanes at major intersections. It has a wide shoulder but no curb and gutter. Bioswales were provided in selected locations on both sides of the road in the planting strip behind the shoulder. They were complemented by matching (same plant material, but mounded) landscaped plantings interspersed along the road. The project was completed in 2012; it has just finished the two-year contractor establishment period. The project was funded through general transportation funds, with an NRDC grant providing \$200,000 toward the total cost.

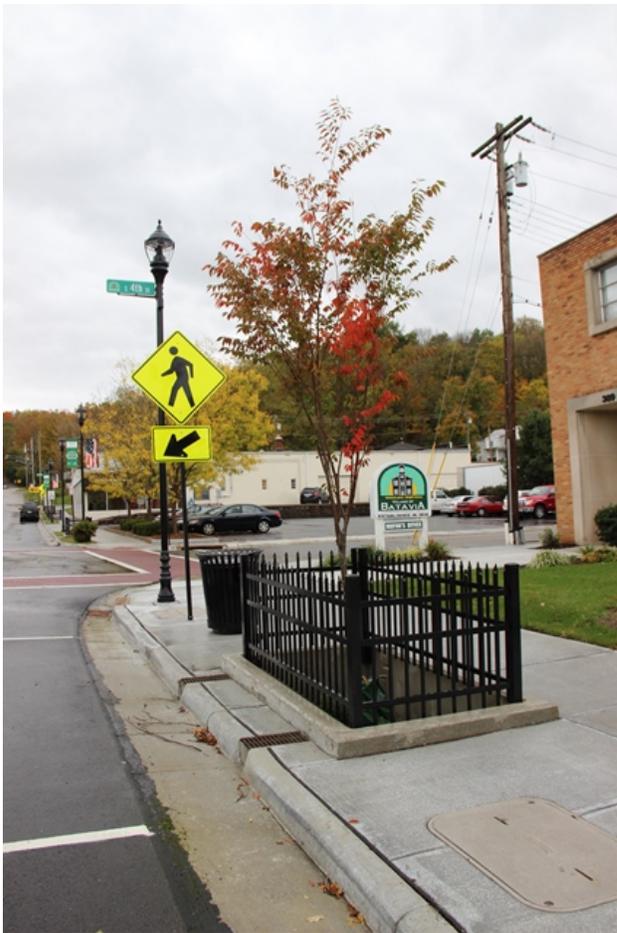
Overview. The “bioswale retention planters” were installed to provide storm water treatment, as a condition of receiving an Ohio Public Works Commission grant of \$2 million toward the \$5 million reconstruction of Main Street. 40 bioretention planter boxes were installed along East Main Street. The purpose of the system was to retain and treat first flush storm flows from street runoff, and allow it to percolate through bioretention plants and soil mix. Because the project was in the center of Batavia Village, attention was paid to design.
