RIVERBANKS MANAGEMENT PROJECTS Cuyahoga Valley National Park, Cuyahoga & Summit Counties

Project Experience

Cuyahoga Valley National Park IDIQ Contract

Riverbank Management

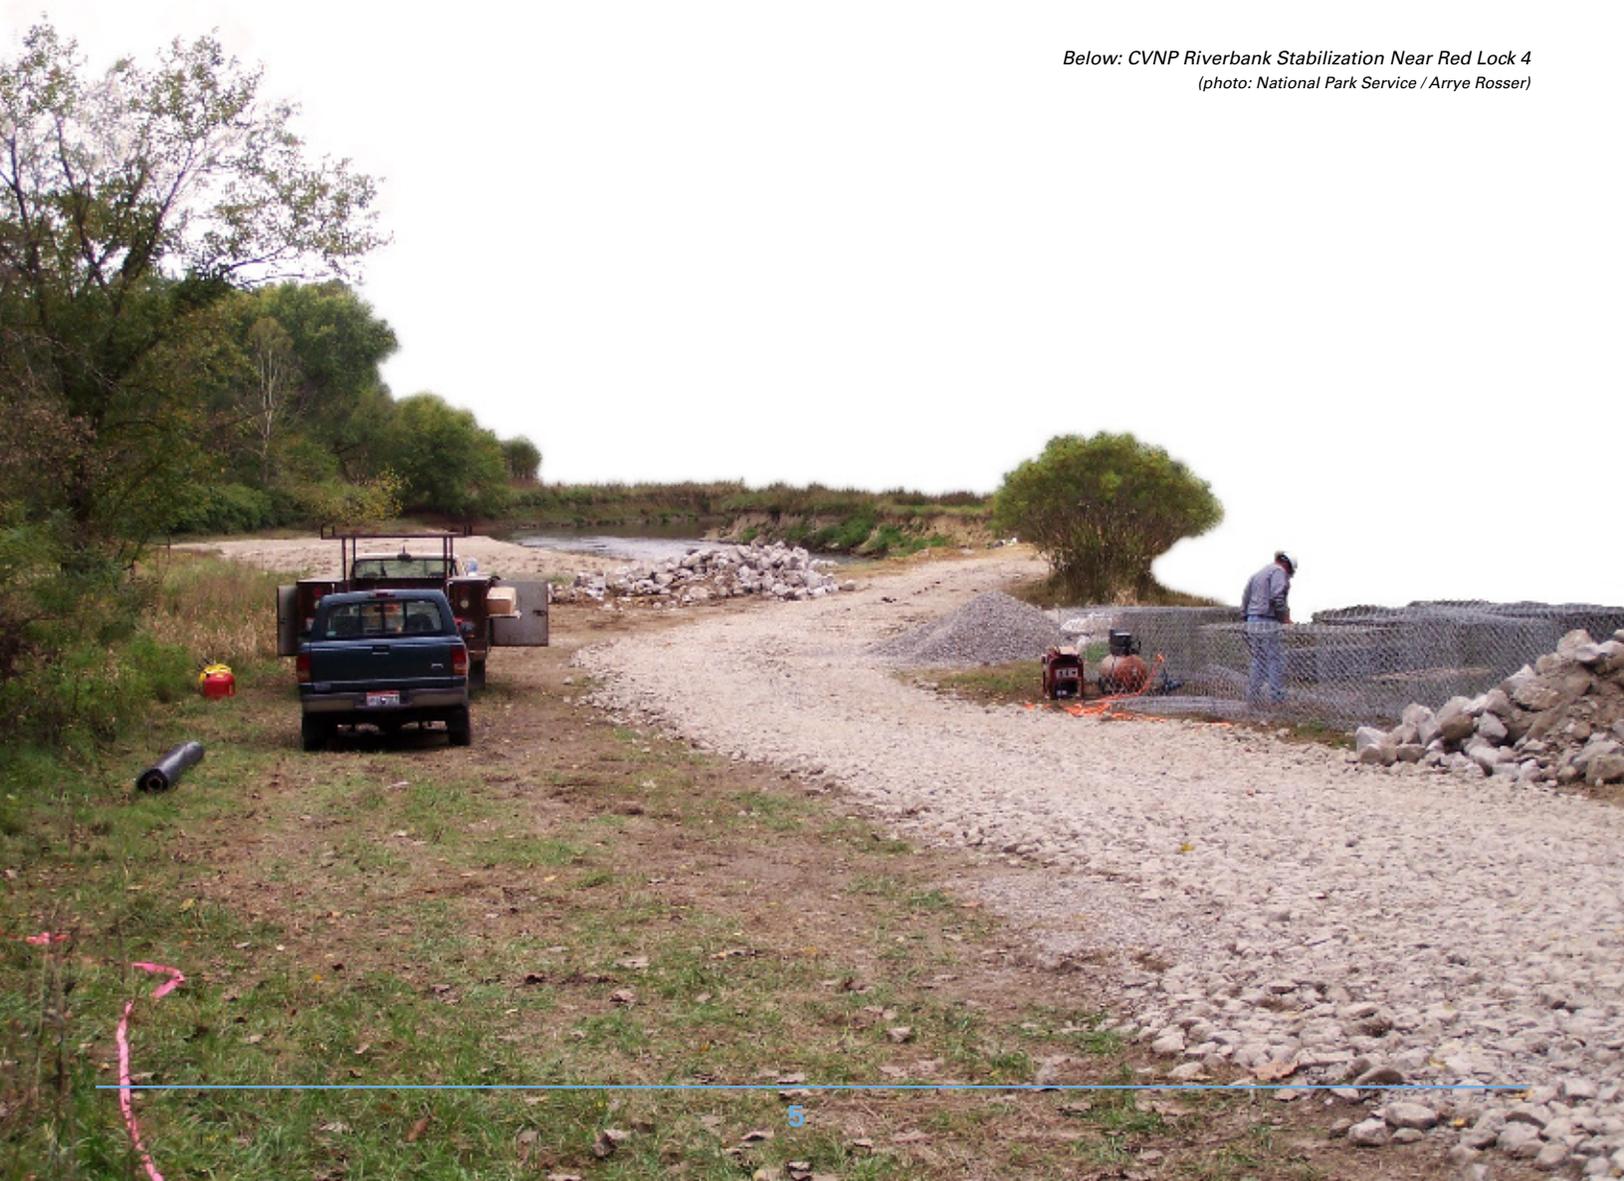
*Below: CVNP Riverbank Stabilization Near Red Lock 4
(photo: National Park Service / Arrye Rosser)*
