# TINKERS CREEK STREAM RESTORATION AND SLOPE STABILIZATION

### Valley View, Cuyahoga County

## Tinkers Creek Stream Restoration and Slope Stabilization Valley View, Ohio

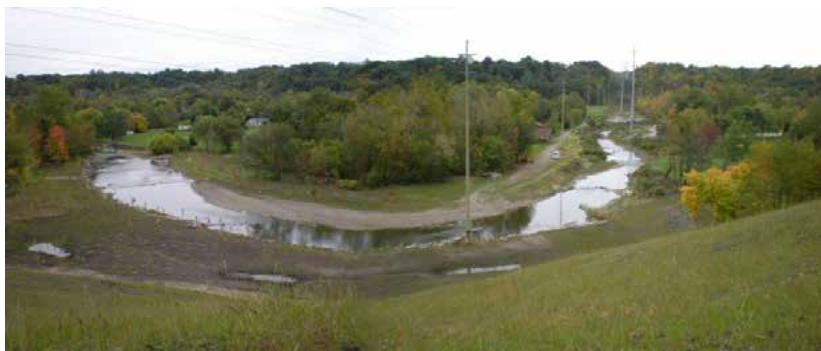
Relocated to its location in the 1970's, the stream moved more than 300' from its position at the beginning of the project (see below construction photo). Native floodplain vegetation including trees and whip plantings are beginning to establish.

The \$2 million construction project relocated the stream more than 300 ft to the north, to its historical location, to allow for the stabilization of the unstable slope. Stream restoration included an extensive analysis of a nearby reference reach to determine the stream width, radius, and profile. Stabilization of the stream bank was accomplished with native rock with joint plantings of willow and dogwood stakes. Stream design included the following design elements: rock vanes, rock cross vanes, stream riffles, log diggers to control high velocities as well as enhance habitat.

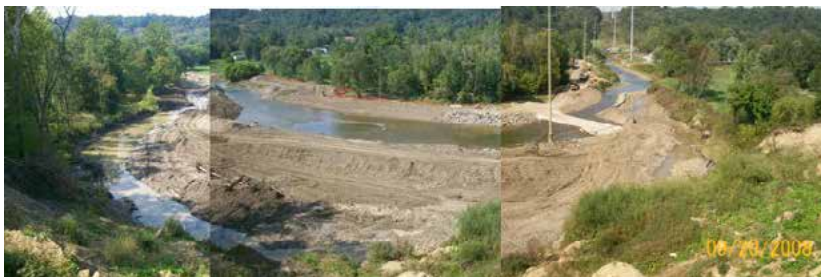
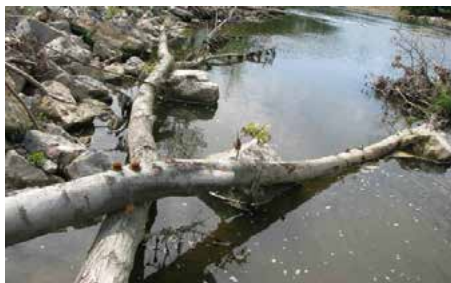
In stream log structures were imbedded into the shoreline to increase fish habitat, provide roughens in the stream, and armors channel.

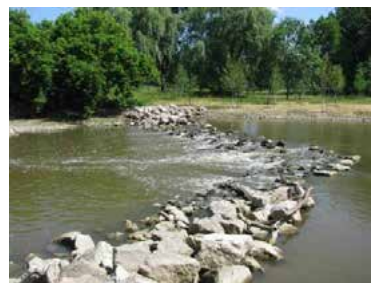
The relocated stream and constructed rock vanes channel water towards the center of the stream, reducing erosion.

- many slope slumps are the result of groundwater saturating and weakening soils
- large streams can be relocated successfully using natural channel techniques
- stream structures such as rock vanes are effective in diverting erosive flows
- compost topsoil applied to the surface of the 100' high slope did not exhibit any gullying or erosion during seed establishment
